BARTON GULLY MASTERPLAN DRAFT

FEBRUARY 2021

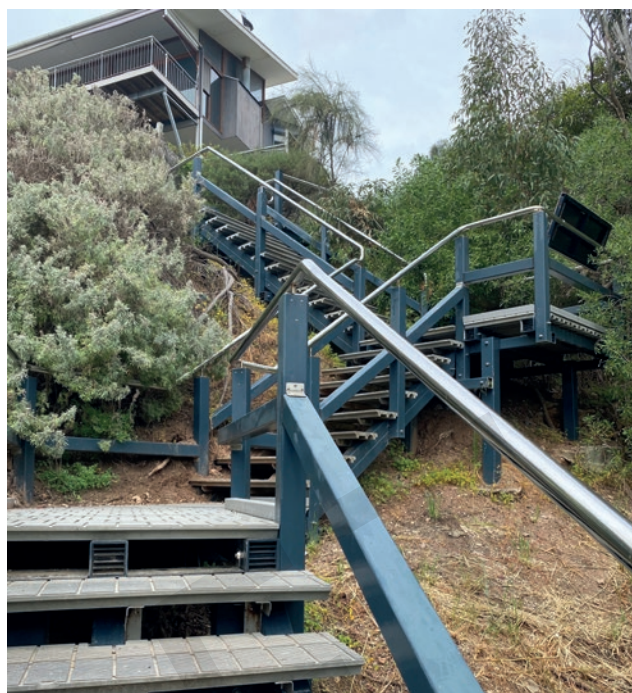
Informal tracks have steadily been replaced by Council with more formal trails and steps in steep areas to encourage appropriate use and reduce erosion. An example of this is the composite fibre and recycled plastic staircase and boardwalk installed by Council in 2012. The boardwalk and staircase have an expected life of over 40 years and will require little maintenance. In addition, two log benches have been installed in the eastern and southern areas of the gully.

Figure 2. Composite fibre and recycled plastic staircase.

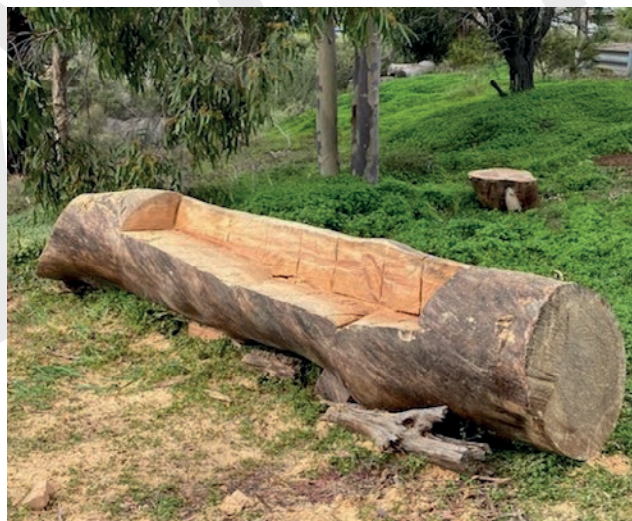
Figure 3. Log bench.

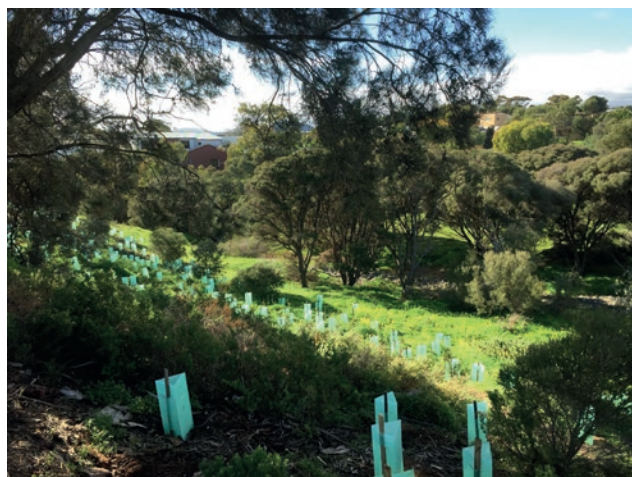
Figure 4. Barton Gully revegetation.

Additional revegetation is planned by Council for the gully consistent with this masterplan's recommendations.

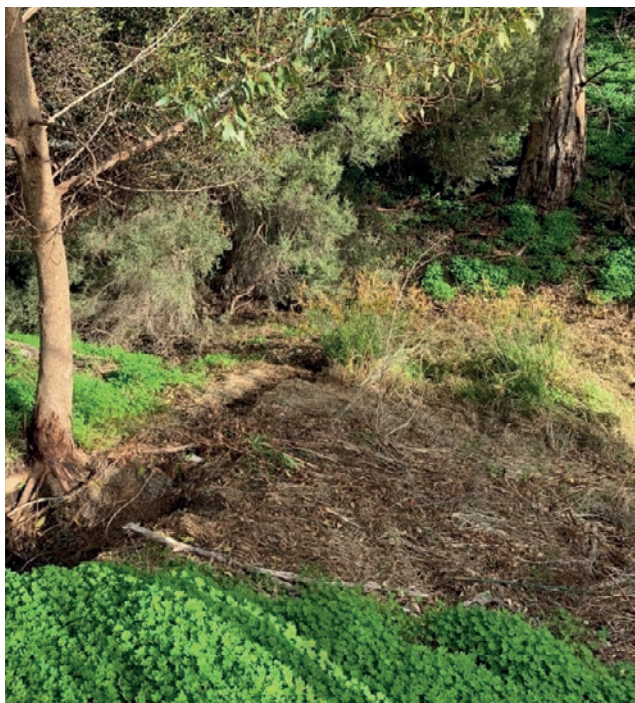
Barton Gully is quite steep in places and therefore when it rains, water flows quickly through the gully, causing erosion and carrying sediment out of the gully.

Figure 6. Erosion caused by stormwater flows.

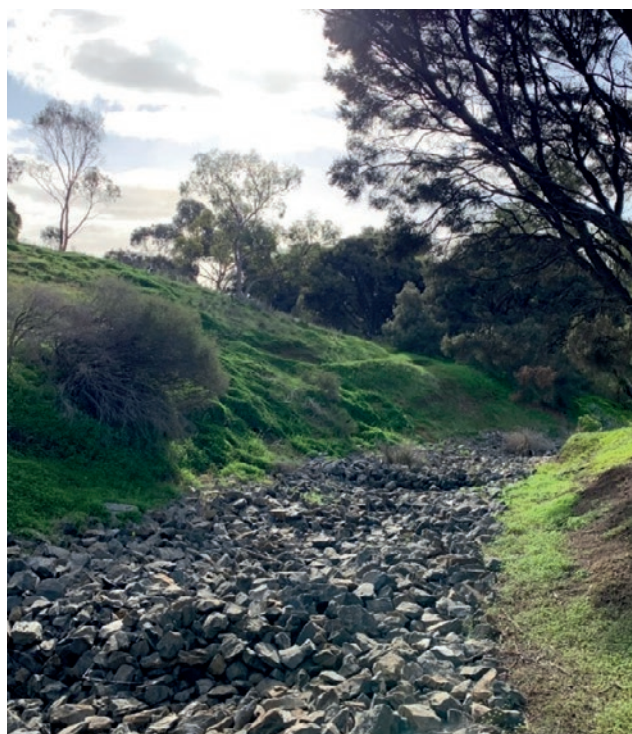
Significant rock lining of watercourses has been completed and whilst preventing erosion, it is considered excessive leading to reduced revegetation of the watercourses (refer Figure 6). This rock lining can be improved to reduce the visual extent of the rock work and allow planting in between rocks to improve water quality, assist in slowing the water and reduce the heat load created by the rocks. In addition, the rock weirs can be improved to create local ephemeral ponds (temporary ponds that slow the water down) for vegetation and to capture silt.

Figure 7. Excessive watercourse rock lining.

There is the opportunity to improve the management of stormwater within the steeper section of the gully by implementing measures that slow the speed of water flow, reduce erosion and improve the quality of the water before it leaves the gully. These measures include stopping the scouring that is active, revegetation of eroded sections of the watercourse with native species and reshaping of the bed and banks to provide increased bank stability.

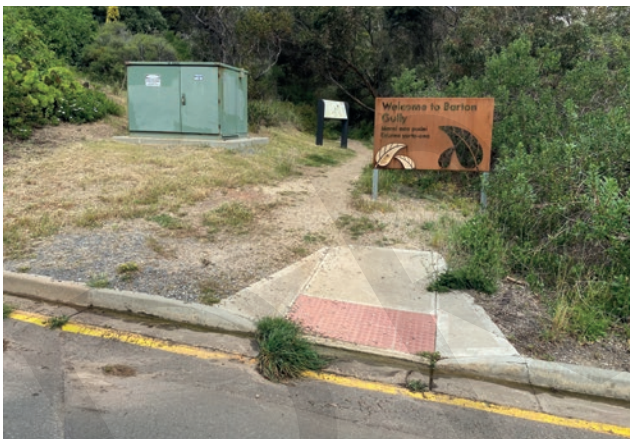
Figure 8. Existing signage at Burnham Road entry.

The existing educational signage could be continued throughout the site to coincide with the restoration and revegetation works.

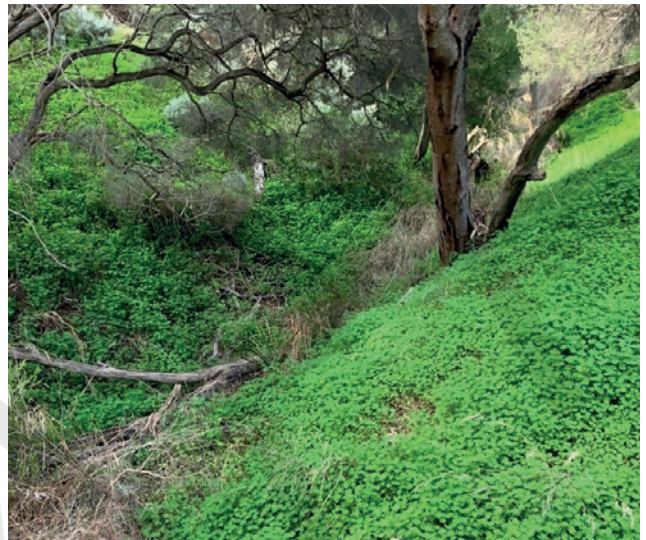
Figure 9. Steeply sloped section of the gully.

The site has one patch of remnant native vegetation and areas where native plants have been re-established. The sloping site does present challenges for revegetation because of restricted access in some areas. Some of the replantings used species that are not local or suitable to the gully environment and these should be gradually replaced with appropriate species. This is especially the case with some of the larger trees that line the narrow path to the coast.

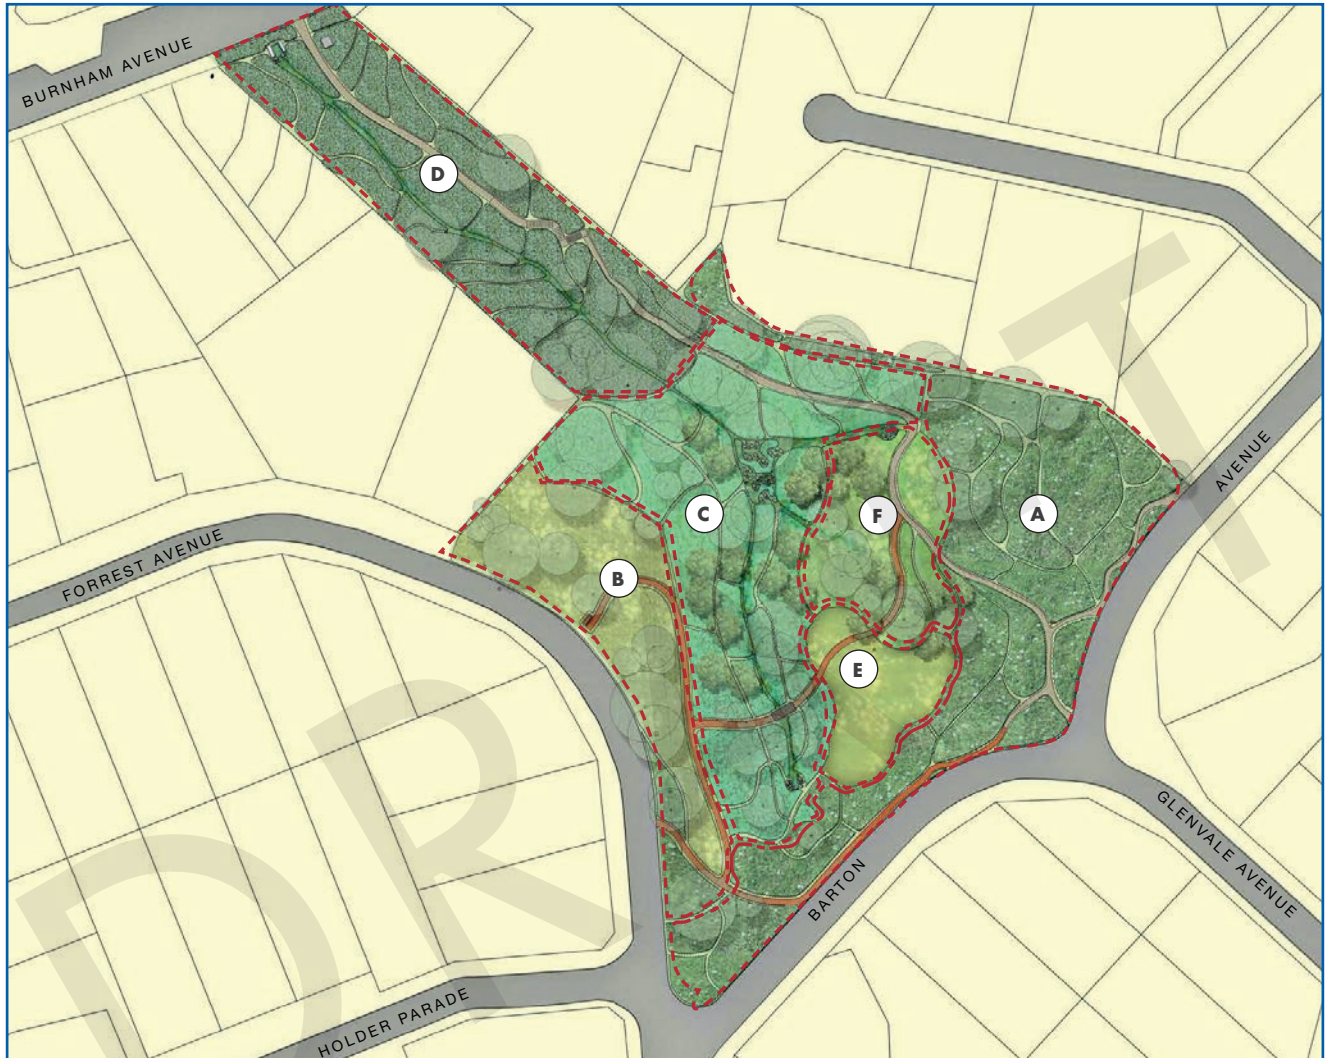
Figure 10. Vegetation zones.

ZONE A - REVEGETATION

- Weeding/slashing before each growing season
- Planting of open areas at density of 2 plants/m²

ZONE B - DRYLAND SLOPE

- Maintain openness
- Removal of non-native species
- Planting of native grasses, sedges and herbs i.e. *Dianella revoluta*, *Austrostipa* spp.

ZONE C - GULLY DRAINAGE LINE

- Planting of tree species *Melaleuca lanceolata*
- Removal of non-native *Melaleuca* species
- New planting of *Cyperus* sp, *Austrostipa* sp, *Juncus* sp and *Lomandra* sp.

ZONE D - LOWER WATERCOURSE

- Removal of weed species
- Selected planting of coastal species
- Groundcover planting of *Myoporum parvifolium* to suppress weeds
- Replace non-native trees with appropriate native tree species

ZONE E - OPEN SPACE AREA

- Maintain open grassland
- Planting of more grassland species eg. *Lomandra* sp., *Themeda* sp., *Austrostipa* sp.
- Encourage grassland species by periodic brush cutting
- Remove large shrubs to maintain grassland habitat

ZONE F - OPEN GRASSLAND AREA

- Maintain open grassland
- Encourage grassland species regeneration by periodic brush cutting
- Remove large shrubs to maintain grassland habitat

Barton Gully has been divided into six distinct vegetation zones, based on the existing vegetation and landscape features. These vegetation zones will be used to assist with revegetation and weed control. The following vegetation zones are shown in Figure 10:

- Zone A: Revegetation area
- Zone B: North facing slope on southern side of gully
- Zone C: gully drainage
- Zone D: Lower watercourse
- Zone E: Open area with some remnant vegetation
- Zone F: Open area with some remnant vegetation

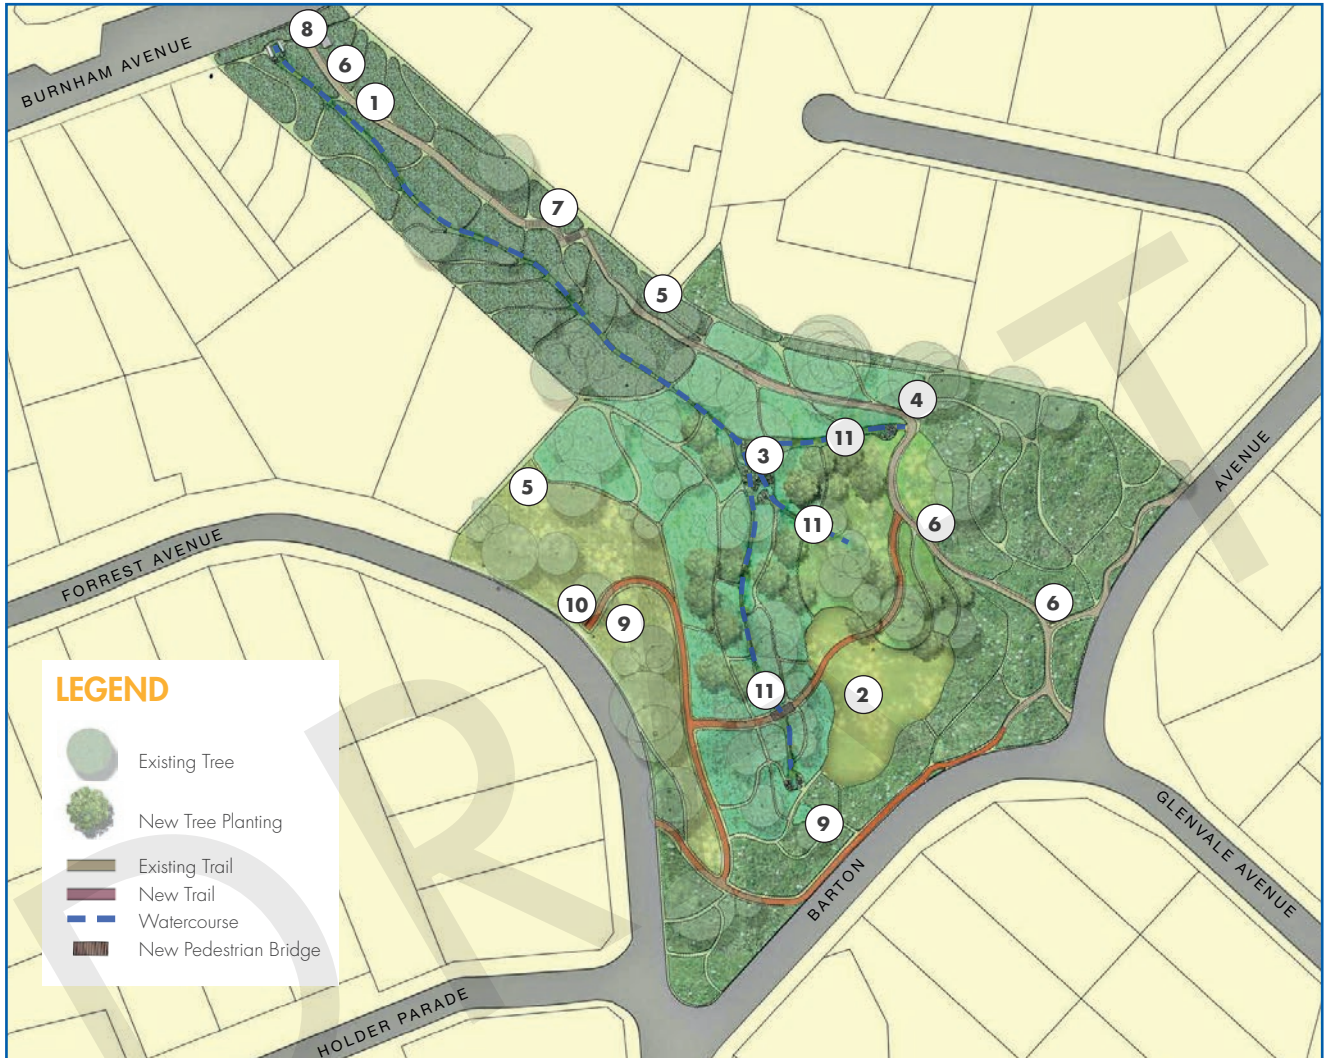
Figure 11. Barton Gully masterplan recommendations.

| 1. Existing trail linking foreshore with gully. | 5. Steep grades revegetated and stabilised. | 10. Install new log seat at viewpoint at end of new path. |
| 2. Open grassed area. | 6. Existing signage. | 11. Revegetation to slow water and mitigate erosion within channel. |
| 3. Potential water retention opportunity and <i>Oxalis perennans</i> propagation site. | 7. Stabilise embankments. | |
| 4. Existing trail widened and benched into embankment to improve access. | 8. Existing trail link. | |
| | 9. Limit tree planting to maintain residents views. | |

The recommendations outlined in this section provide direction to enhance the existing biodiversity and improve access for the community to enjoy the natural environment provided by Barton Gully. Figure 11 shows the location for each of the recommendations.

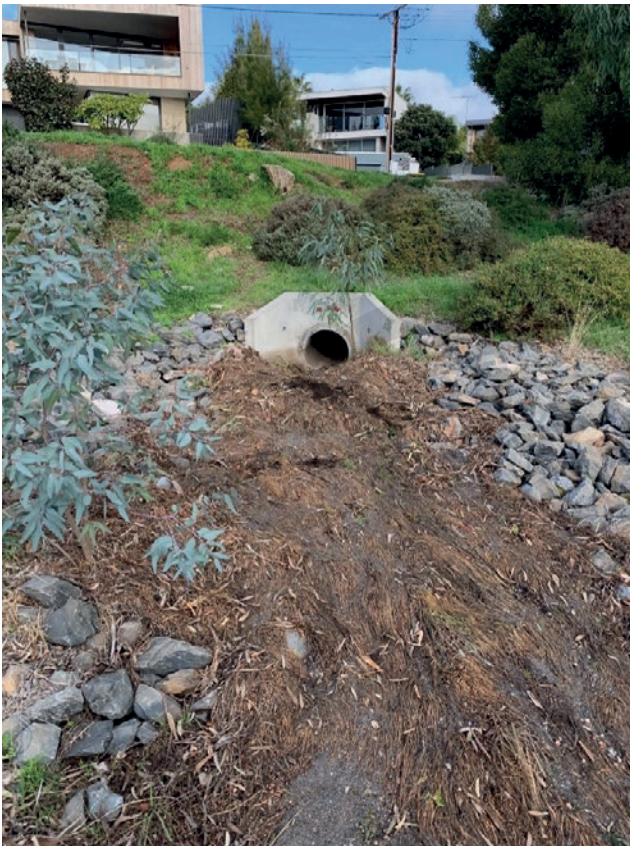
The inlet has recently been upgraded to minimise erosion. The placement of informal stepping stones across the riffle will improve the safety for people crossing at that location.

Figure 12. Barton Road stormwater discharge into Barton Gully.

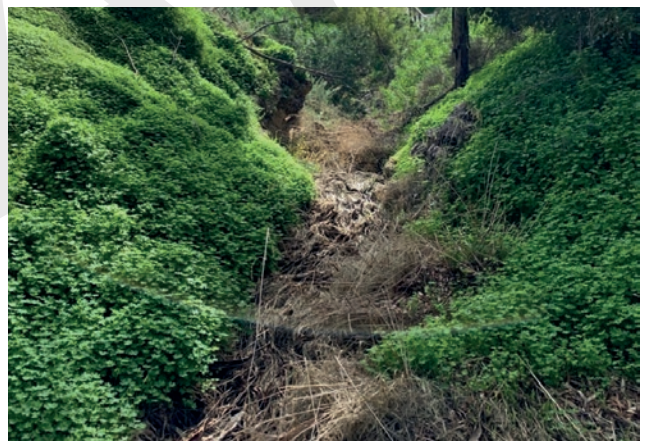
The main drainage lines through the upstream gully have been rock armoured and are in good condition. Some improvement to create check dams and planting pockets is recommended. The downstream gully shows signs of erosion at several locations and it is recommended that these areas be remediated, and erosion protection measures deployed to minimise any future or ongoing erosion. The following solutions will be considered for erosion protection, including:

- Rock lining along incised sections of the gully invert
- Rock “leaky” check-dams
- Turf reinforcement mat with vegetation

Figure 13. Erosion in Barton Gully.
