Welcome to Gilbertson Gully

GILBERTSON GULLY MASTERPLAN DRAFT

FEBRUARY 2021

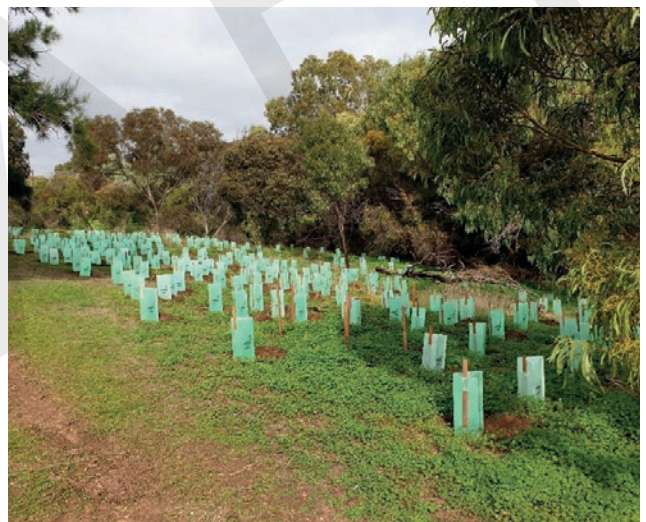
Figure 3. Winter 2020 revegetation plantings.

Most recently, 4,155 new plants including local native grasses, ground covers, wildflowers, climbers, shrubs and small trees were planted in the winter of 2020. The recent revegetation of the gully is consistent with this masterplan's recommendations.

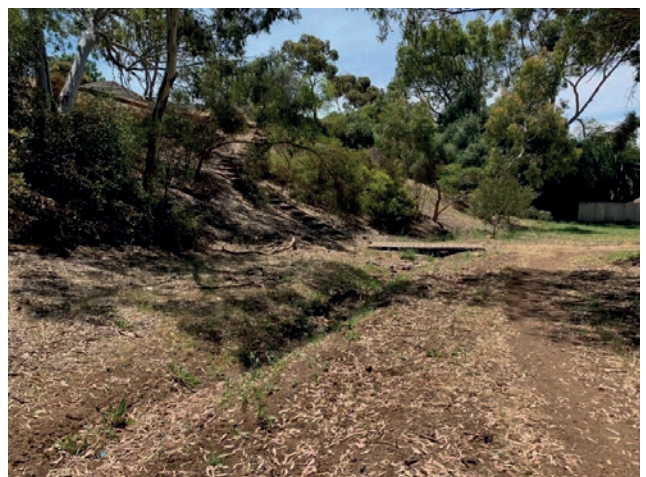
Figure 4. Makeshift bridge over creek line.

The local community has installed makeshift bridges over the creek in some locations.

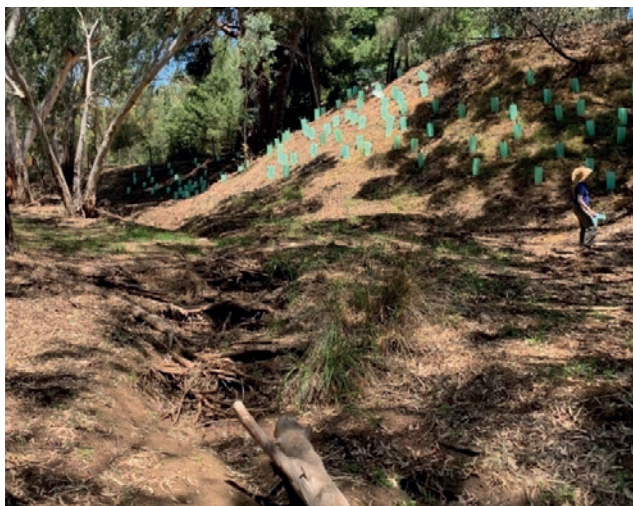
Figure 6. Watercourse erosion.

Gilbertson Gully is quite steep in places and therefore when it rains, water flows quickly through the gully, causing erosion and carrying sediment out of the gully.

There is an opportunity to improve the management of stormwater within the gully by implementing measures that slow the speed of water flow, reduce erosion and improve the quality of the water before it leaves the gully. These measures include rock stabilisation and revegetation of eroded sections of the watercourse with native species as well as reshaping of embankments to provide increased bank stability. Refer to Appendix A for further information on the identified stormwater improvements.

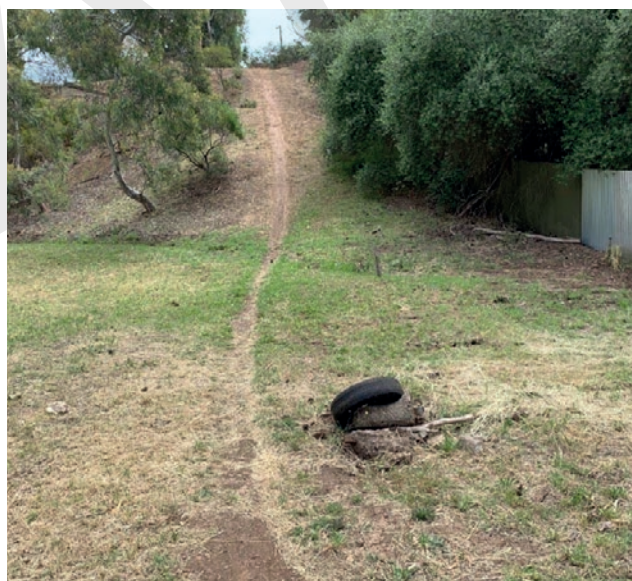
Figure 7. Informal entry trail at downstream end of gully.

The steep nature of the gully restricts access in some areas and informal tracks have been created by people in other areas, sometimes causing additional erosion of the slopes. The steep slopes of the embankments may also cause difficulties in establishing revegetated areas because movement around the site is challenging and because of the need to maintain bank stability. Plants suitable for the sloping site will help to maintain the integrity of the soil and mitigate further erosion. Maintaining ground cover while revegetating will also be important, to ensure that additional erosion does not occur before new plantings are established.

There is the opportunity to formalise existing sections of the trail network around key entry points into the gully. This is particularly important along the steeper sections of the gully, where informal paths have contributed to erosion. New trail alignments and linkages can be created that will provide safer access to visitors and create a sustainable trail network that reduces annual maintenance.

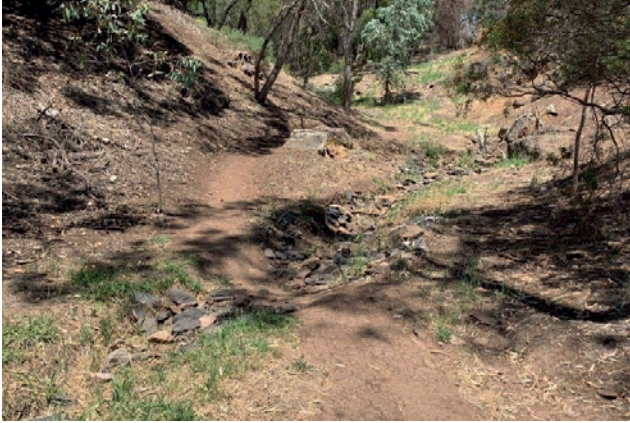
Figure 8. Existing creek crossing point.

There is the opportunity to upgrade the northern steps (near Lamington Avenue) to provide safety and an improved alignment, linking to a new footbridge (as above comment). The degraded steps in the south of the gully (near the entry off Mann Street) could also be replaced with a trail that descends the embankment gently and links to a new footbridge (as above comment) across the watercourse.

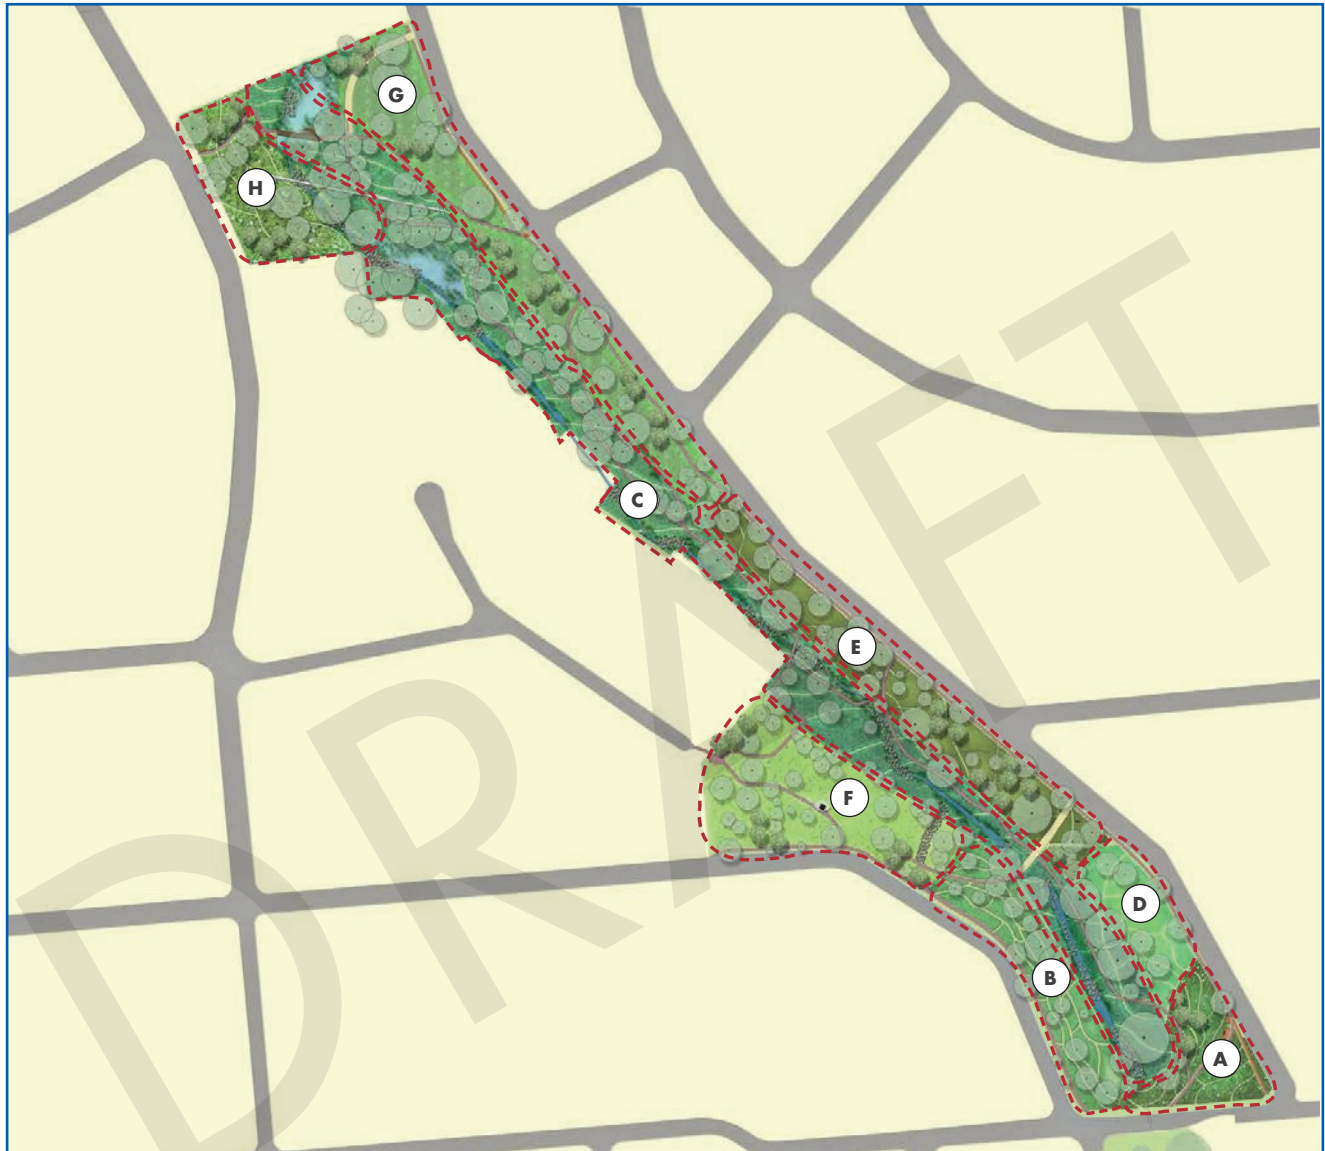
Figure 9. Vegetation zones.

ZONE A - REVEGETATION AT HIGHLY VISIBLE ROAD CORNER

- Weed control followed by revegetation with higher density to enhance existing revegetation and prevent weeds.
- Control infestation of weeds before further revegetation planting.
- Test nutrient levels
- Ameliorate soil in order to deal with high levels of nitrogen and phosphorus which is currently responsible for the increase in weeds in this area.
- Encourage slash/weed/spray prior to seed set.

ZONE B - EAST-FACING EMBANKMENT ABOVE THE WATERCOURSE

- Control weed species (soursob) with spray to control
- Slow release fertiliser and organic mulch to assist replanting
- Planting of *Bursaria spinosa*, *Calytrix tetragona* and *Pomaderris paniculata*
- Christmas bush in clumps of 10, at 1.5m spacings.

ZONE C - WATERCOURSE

- Removal of woody weeds and weed tree species
- Control of weed grasses such as kikuyu and annual veldt grass
- New planting of *Cyperus sp.*, *Juncus pallidus* in areas of inundation at 300mm spacings to assist with erosion control
- New planting of *Dianella revoluta* var. *revoluta* and *Aurolistia elegantissima* in ephemeral areas

ZONE D - WEST-FACING EMBANKMENT ABOVE THE WATERCOURSE

- Removal of weed species
- Selected planting of low shrubs, grasses and sedges such as *Acacia acinacea*, *Maireana enchylaenoides*, *Atriplex semibaccata*, *Kennedia prostrata*

ZONE E - SECTION OF THE WEST-FACING EMBANKMENT

- Infested with *Fumaria sp.* Bank is dry,
- Planting of the following species: *Maireana enchylaenoides*, *Atriplex semibaccata*, *Austrodanthonia caespitosa*, *Kennedia prostrata* and *Lomandra multiflora*.
- Selected removal of *Allocasuarina sp.*

ZONE F - ROCKY OUTCROP AND TOP OF THE RISE

- Remnant vegetation of native pine, peppermint box, native apricot, along with and understorey of native grasses, sedges, lilies.
- Priority area for selective weed control to encourage natural regeneration.

ZONE G - RIDGETOP EASTERN SIDE OF GULLY

- Remnant vegetation in moderate-good condition.
- Open woodland with an understorey of grasses, sedges, low herbs and lilies.
- Maintain grassland and brushcut at appropriate times.
- Additional planting limited to native grasses, sedges and lilies to enhance native vegetation.

ZONE H - NORTH-WESTERN END STEEP SLOPE SHADED BY PLANTED TREES.

- A dry area where current vegetation not well-suited to the site.
- Removal of specific weed species including *Fumaria* and *Boxthorn*.
- Leave for 1 year before revegetation
- Plant with species such as *Maireana sp.*, *Atriplex sp.*, *Austrodanthonia sp.*, *Kennedia sp.*, *Lomandra sp.*, and larger shrubs such as *Acacia pycnantha*, *Pittosporum angustifolium* and *Melaleuca lanceolata*.

Gilbertson Gully has been divided into eight distinct vegetation zones, based on the existing vegetation and landscape features. These vegetation zones will be used to assist with revegetation and weed control. The following vegetation zones are shown in Figure 9:

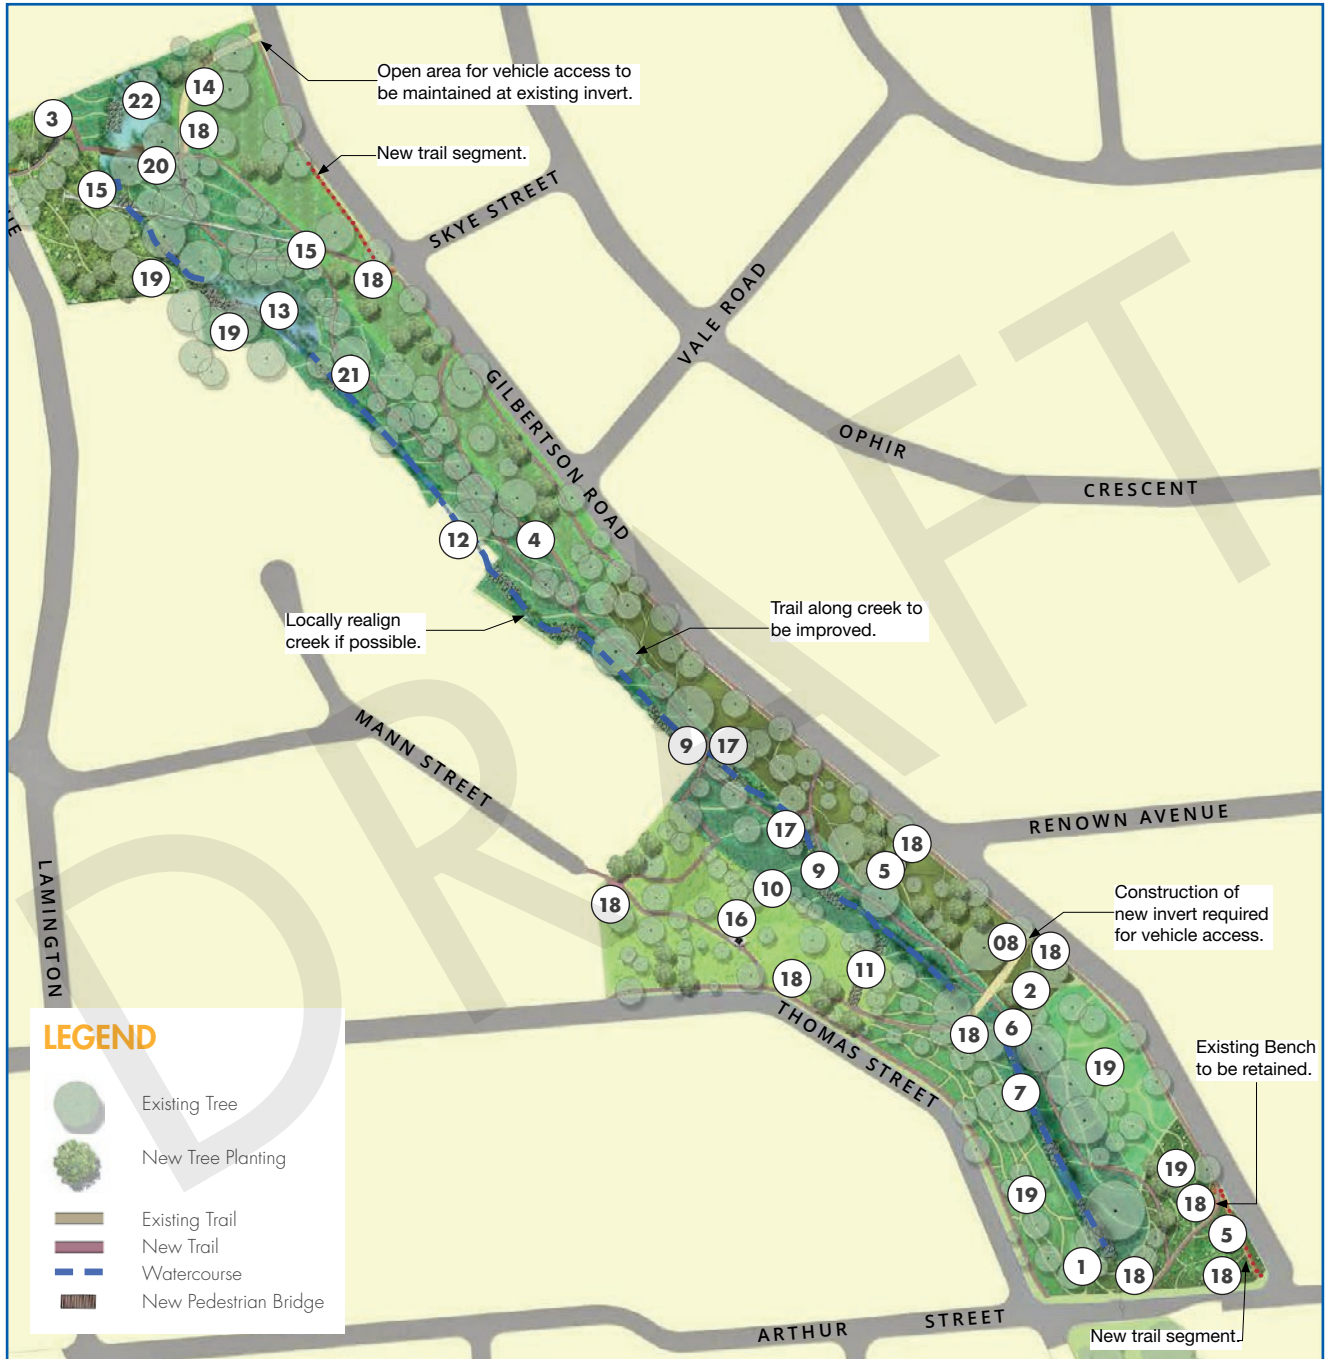
Figure 10. Gilbertson Gully masterplan recommendations.

1. Repair headwall apron, remediate and revegetate. Consideration of upstream GPT possible in future years.
2. Stabilise embankment.
3. Consider upgrade and possible/minor realignment of steps for improved access and reduced grades and erosion.

4. New trail higher on bank, away from watercourse (as well as maintaining path along watercourse).
5. Formalised and enhanced trail network.
6. Installation of new trash rack or WSUD treatment to reduce blockages.

14. Improve vehicle access for maintenance to water quality improvement basins.
15. Liaise with SA Water to repair pipe headwalls.
16. New informal seating.

The recommendations outlined in this section provide direction to enhance the existing biodiversity, reduce erosion, and improve access and amenity for the community to enjoy the natural environment of the gully. Figure 10 shows the location for each of the recommendations.

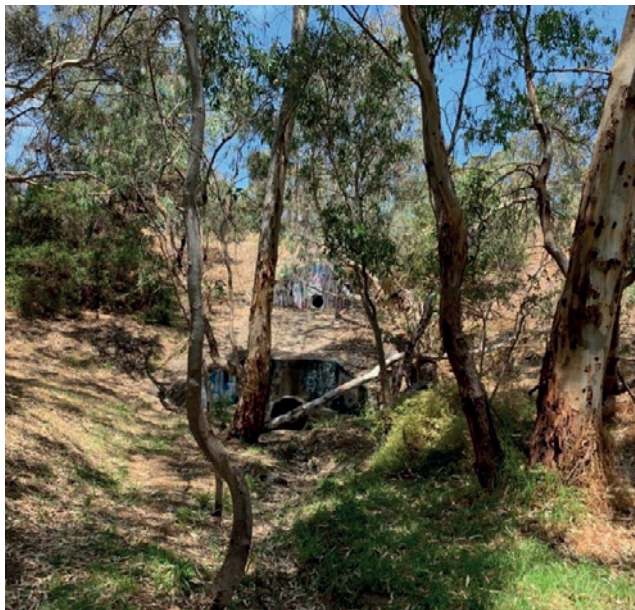
Figure 11. Upstream drainage infrastructure.

An embankment currently crosses the gully, with low flow culverts projecting through it, effectively forming a detention basin in large stormwater events. Whilst the detention has no significant impact to downstream flood flows, it provides an opportunity to create a small wetland. The culvert entry has trash screens installed; however, these are observed to be regularly clogged with debris, and significantly restrict drainage into the culverts. This should be reviewed and an alternative solution developed that does not require

significant maintenance and can retain small amounts of water to create a small wetland. The installation of an upstream GPT near Arthur Street could also help to reduce loadings of leaf litter.

There is also an opportunity to excavate in front of the embankment, within this detention area, to allow for additional ponding, water retention and sedimentation, which will improve water quality and assist in mitigating culvert blockages.

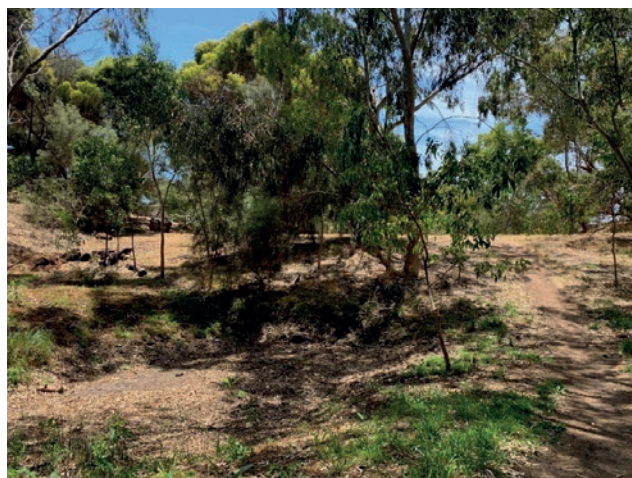
Figure 13. Upstream of existing detention basin.

Some stormwater works have been undertaken to create a detention basin although this has been largely unsuccessful due to the design and constant blockage by vegetation debris. Some erosion protection has also been installed although this also has been only partially successful due to the fast flowing stormwater.

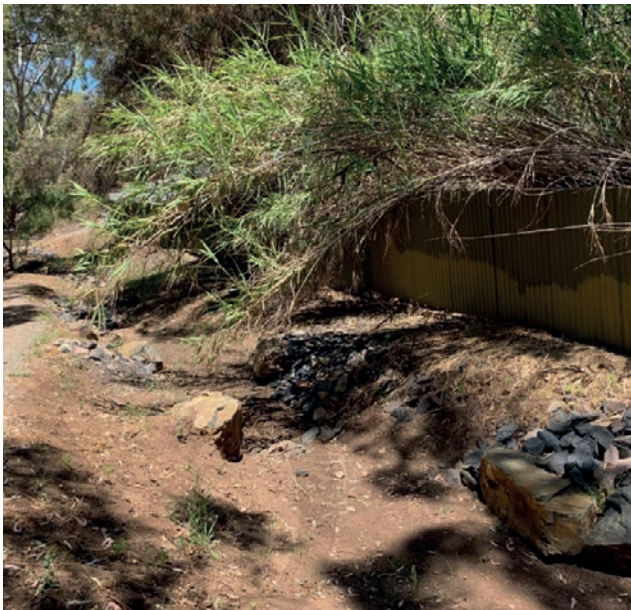
Figure 14. Erosion along drainage line.

The main drainage line along the gully shows sign of erosion at several locations and it is recommended that any eroded areas be remediated, and erosion protection measures deployed to minimise future ongoing erosion. There are several options that may be considered for erosion protection, including:

- Rock lining along incised sections of the gully invert
- Rock “leaky” check-dams
- Turf reinforcement mat with vegetation.

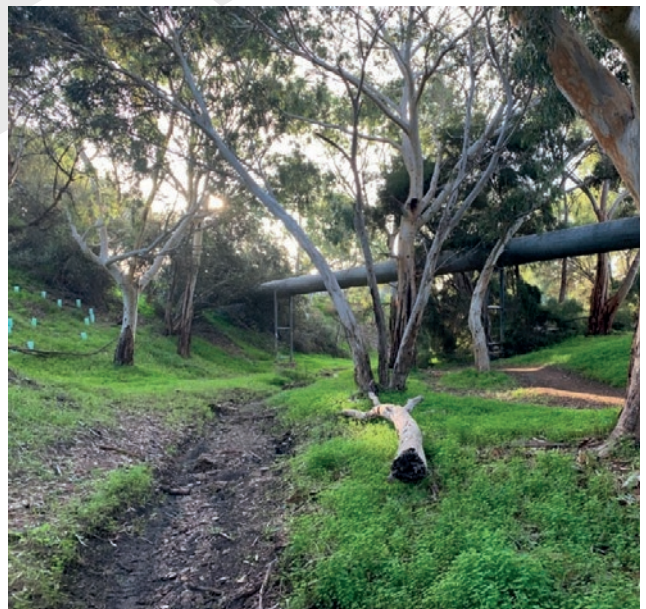
Figure 15. Water supply crossing.

The headwall surrounds and the exposed structure to the above ground water supply pipeline crossing near Gilbertson Road has deteriorated and it is recommended that Council liaise with SA Water to assess and remedy if required.
