Welcome to Pine Gully

PINE GULLY MASTERPLAN DRAFT

FEBRUARY 2021

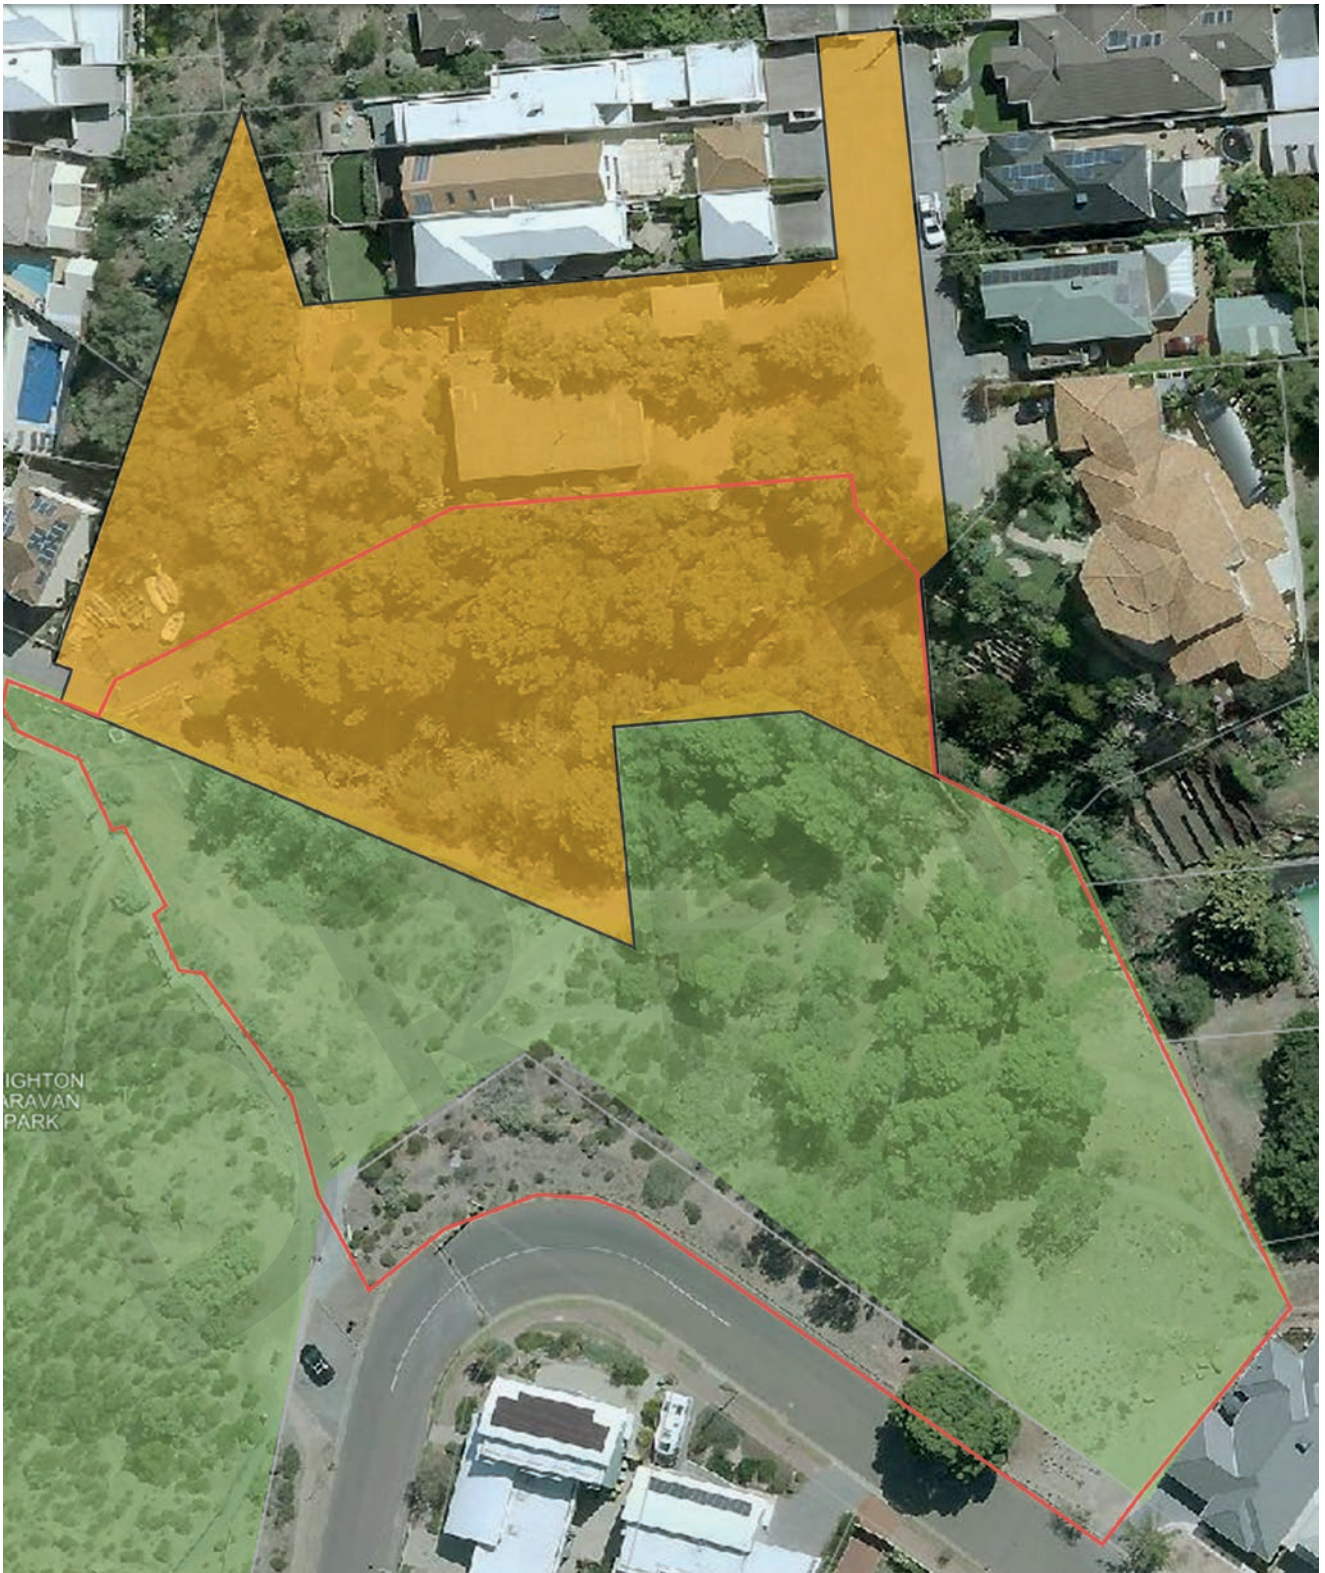
Figure 1. Location of Pine Gully (outlined in red); area in orange is owned by Mrs Mary Trott. The portion of orange inside the red line is the area under care and control of the City of Holdfast Bay.

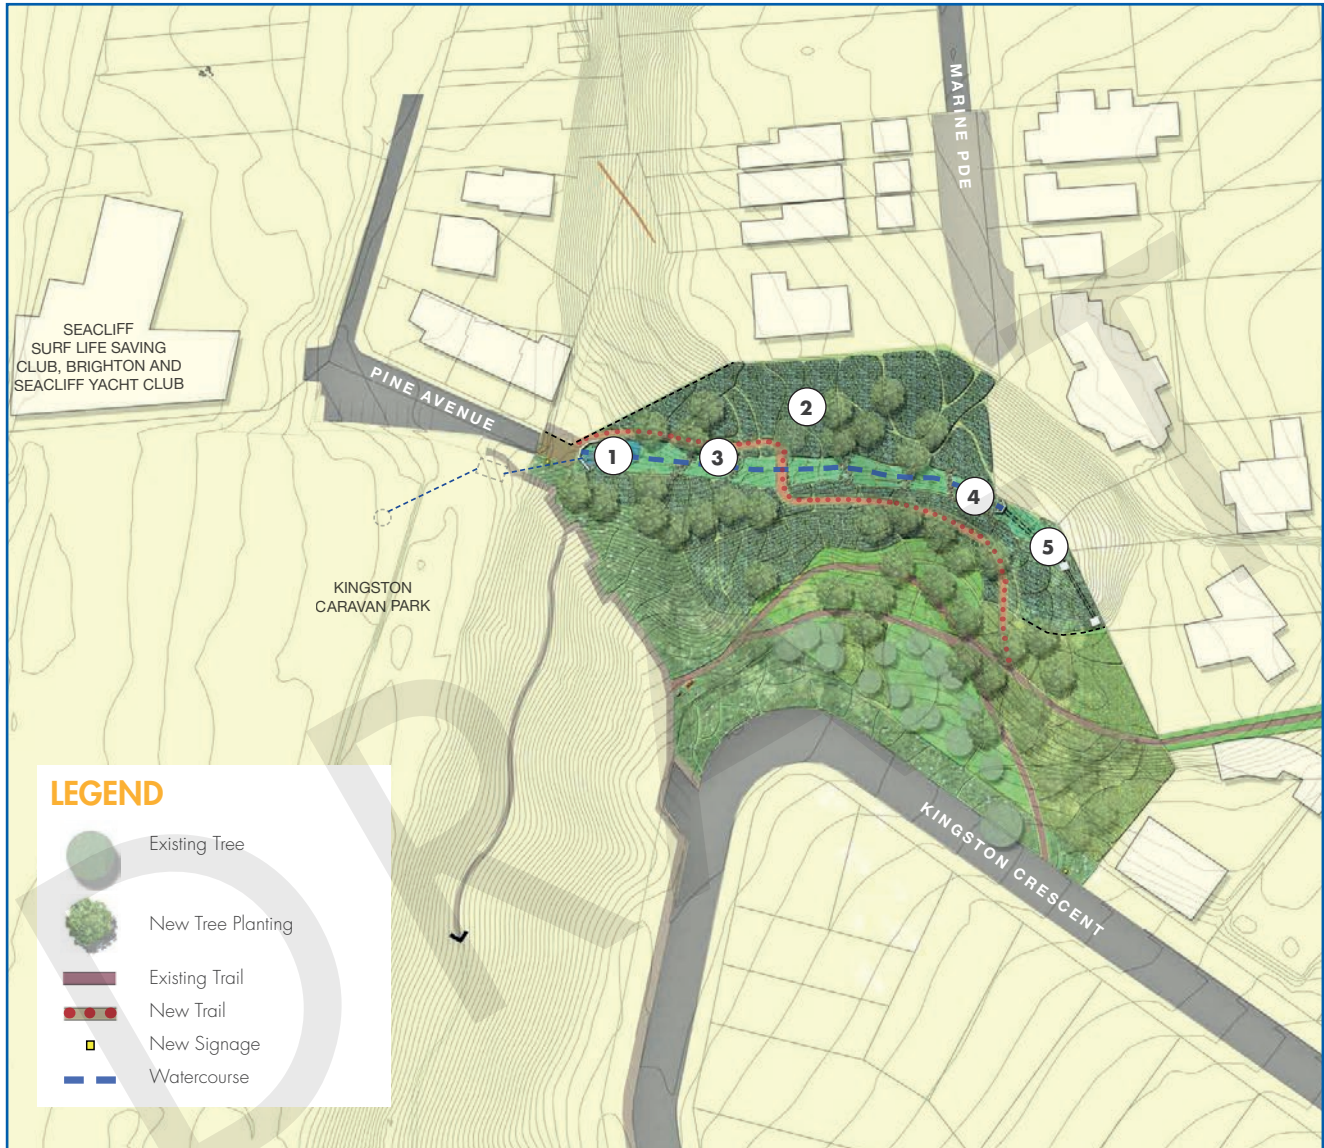
Figure 2. Opportunities and constraints.

4. Remove section of fence spanning the channel or replace with more appropriate structure. Confirm boundary location and fencing with property owner.
5. Extend existing pipe with drop structure to reduce energy at stormwater outlets to open channel in Pine Gully.

The various opportunities and constraints presented by the site have been evaluated in terms of stormwater management, landscape and vegetation. A summary of the evaluation is provided below, with the locations of the opportunities and constraints shown in the attached plan (refer to Figure 2). It is also important given the cultural significance of the site that any planned works carried out in the area be planned in consultation with Kaurna. A review of Pine Gully was undertaken with Kaurna Representatives in September 2019.

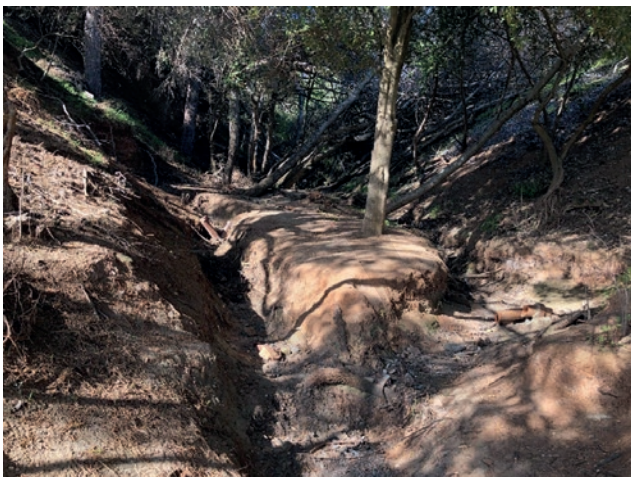
Figure 3. Erosion on steep embankment.

Pine Gully is quite steep in places, with a large, steep upstream catchment and therefore when it rains, water flows quickly through the gully, causing erosion and carrying vegetative material and sediment out of the gully into Gulf St Vincent.

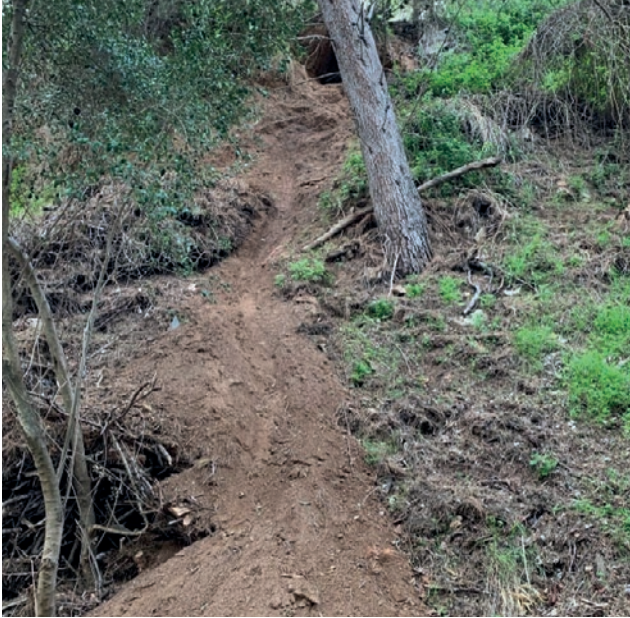
Figure 4. Informal bike trail.

There are a number of informal trails that traverse the southern and flatter part of the gully, with some native vegetation. Multiple narrow, unformed trails currently traverse the steep slopes of the gully causing erosion, particularly those that have been utilised by mountain and BMX bike riders (refer Figure 4). There is the opportunity to formalise existing sections of the trail network within the flatter sections of the gully and close off access to the unsafe steeper trails. This includes a short new path through the flat section of the upper southern part of the gully.

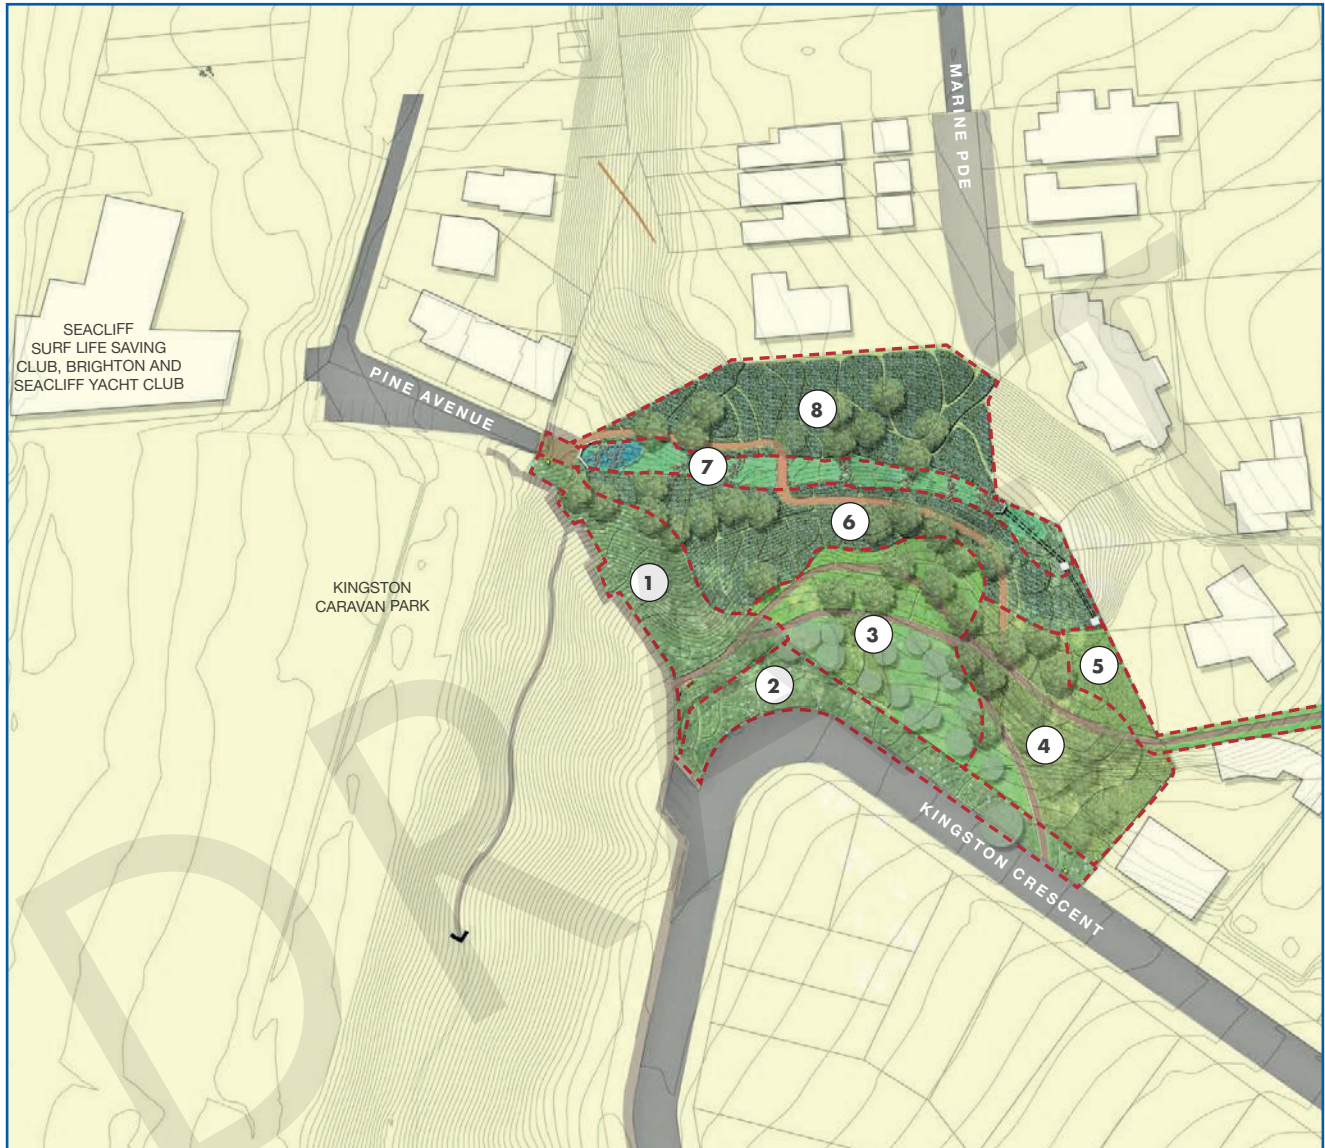
Figure 8. Vegetation zones.

- Very shallow topsoil, lack of soil moisture, exposure to foot traffic and coastal wind.
- Encourage better coverage of *Themeda triandra* (Kangaroo Grass).
- Mulch exposed soils and balanced fertiliser
- Water during first year

Pine Gully has been divided into nine distinct vegetation zones, based on the existing vegetation and landscape features. These vegetation zones will be used to assist with revegetation and weed control. The following vegetation zones are shown in Figure 8:

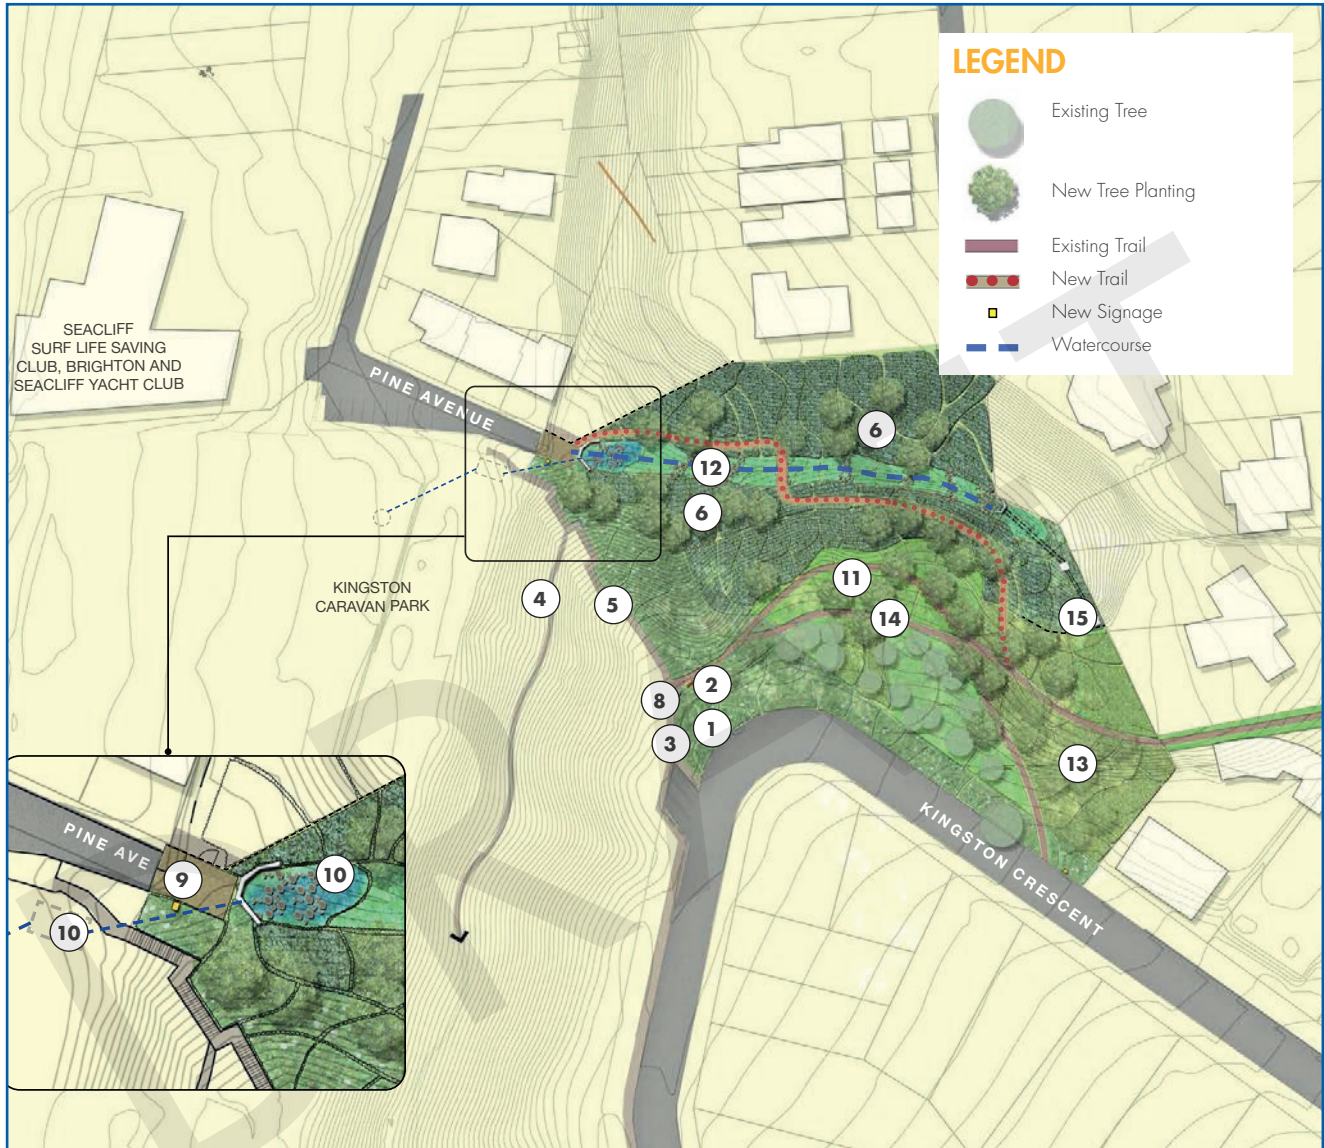
Figure 9. Pine Gully masterplan recommendations.

The recommendations outlined in this section provide direction to enhance the existing biodiversity, improve stormwater management and improve access for the community to enjoy the natural environment provided by Pine Gully. Figure 9 shows the location for each of the recommendations.

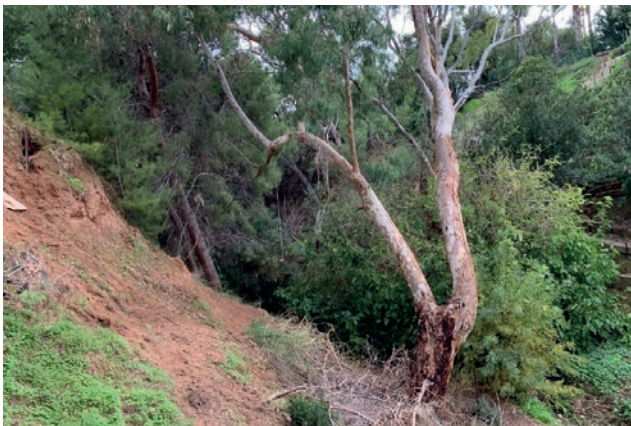
Figure 10. Downstream of upstream outfall.

The watercourse through the gully shows signs of erosion at several locations of both bed and creek batters (refer Figure 10). It is recommended that eroded areas be remediated, and erosion protection measures implemented to minimise future ongoing erosion. The following solutions are proposed:

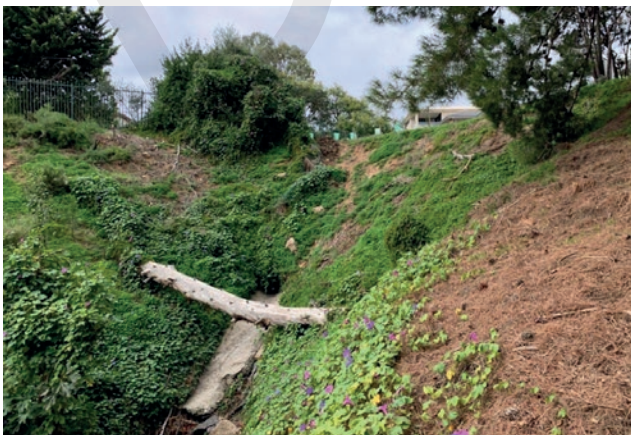
Figure 11. Upstream outfall.

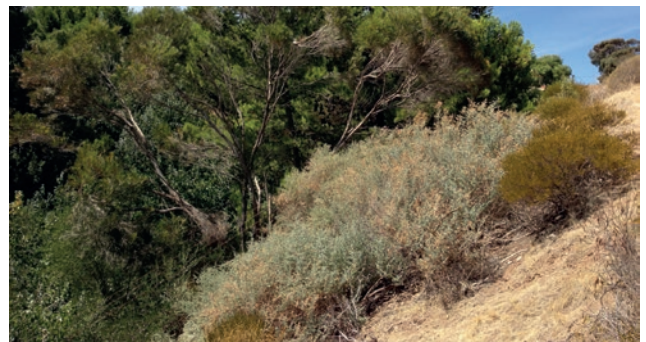
The condition varies along the length of this drain that consists largely of a steep embankment. Various woody weeds occur and should be selectively removed including olives, pepper trees, aloe, athel pines and Aleppo pines. Localised locations of batter erosion are also evident. This is a Zone that could be treated and replanted prior to attempting the northern side batter.

Figure 17. Zone 6 vegetation on batter and drainage line.

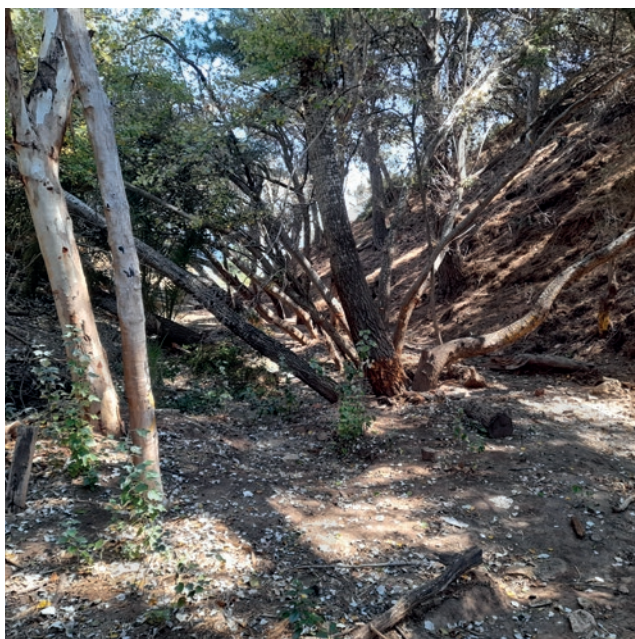
This Zone consists of a highly modified drainage line containing a significant level of introduced tree species including desert ash, red gum (planted), Aleppo pine, olives, silver poplar, and others. There is also a quantity of rubble/mortar that has been dumped here, which is affecting water flow. High level of shading is apparent. Water comes from a drainage pipe entering at the eastern end of the gully where the velocity of the water has caused erosion.

- Clear vegetation to allow light into the drainage line to enable regrowth of any sedges
- Plant with watercourse plants such as *Ficinia nodosa*, *Juncus pallidus* and *Cyperus spp.* to assist with control of silt movement down the watercourse. These plants should be integrated into the scour protection works proposed.
- Continuous control of woody weed seedlings is important

Figure 18. Zone 7 drainage line.
